**DEPARTMENT OF TRANSPORTATION****DIVISION OF ENGINEERING SERVICES**

Contract #: 04-0120F4Cty: SF/ALA Rte: 80 PM: 13.2/13.9File #: 1.28**WELDING INSPECTION REPORT****Resident Engineer:** Casey, William**Address:** 333 Burma Road**City:** Oakland, CA 94607**Report No:** WIR-026288**Date Inspected:** 13-Sep-2011**Project Name:** SAS Superstructure**OSM Arrival Time:** 700**Prime Contractor:** American Bridge/Fluor Enterprises, a JV**OSM Departure Time:** 1530**Contractor:** American Bridge/Fluor Enterprises, a JV**Location:** Job Site**CWI Name:** Tony Sherwood**CWI Present:** Yes No**Inspected CWI report:** Yes No N/A**Rod Oven in Use:** Yes No N/A**Electrode to specification:** Yes No N/A**Weld Procedures Followed:** Yes No N/A**Qualified Welders:** Yes No N/A**Verified Joint Fit-up:** Yes No N/A**Approved Drawings:** Yes No N/A**Approved WPS:** Yes No N/A**Delayed / Cancelled:** Yes No N/A**Bridge No:** 34-0006**Component:** OBG Sections**Summary of Items Observed:**

Self Anchored Suspension (SAS) Tower, Electro Slag Welding (ESW):

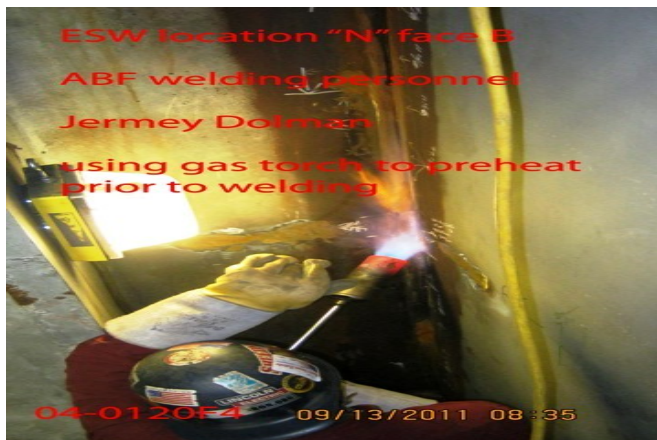
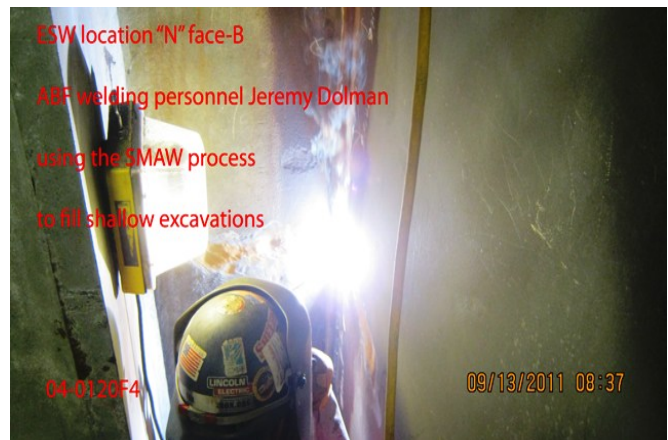
ESW weld location N-face B: This QA Inspector observed ABF welding personnel Jeremy Dolman (# 5042) using a grinder to contour the weld at areas marked by various QC personnel after a visual inspection. The grinding also consisted of shallow excavations (less than 10 mm deep) to remove Magnetic Particle Testing (MT) indications. This QA Inspector observed the work was being performed between the 3-meter and 9-meter elevations. This QA Inspector randomly observed as QC Inspectors Jesus Cayabyab and/or Tony Sherwood performed MT to verify the removal of the various indications. QC Inspector Jesus Cayabyab was present from approximately 0730 hours until 0930 hours and replaced by QC Inspector Tony Sherwood. This QA Inspector observed that after the indications had been removed by grinding and verified with visual and MT by QC personnel ABF welding personnel Jeremy Dolman (# 5042) would use a gas torch to preheat prior to welding, see photo below. This QA Inspector observed ABF welding personnel Jeremy Dolman (# 5042) use a temperature indicating marker to verify the preheat temperature was greater than 300°F. This QA Inspector observed QC Inspector Tony Sherwood verify the following welding parameters; 117 amperes. This QA observed a 3.2 mm diameter E7018H4R electrode was being used. The welding observed this date appeared to comply with Welding Procedure Specification (WPS) ABF-WPS-D15-1002 Repair.

ESW weld location L -face A: This QA Inspector randomly observed ABF personnel Jeff Stone using a grinder to contour the weld between the 3-meter and 9-meter elevation at areas previously marked by various QC personnel.

ESW weld location M -face A: This QA Inspector randomly observed ABF personnel Alex Blanco using a grinder to contour the weld between the 3-meter and 9-meter elevation at areas previously marked by various QC personnel.

ESW weld location G -face B: This QA Inspector randomly observed ABF personnel Alex Blanco later this date using the carbon arc process to remove the temporary welds which held the strong backs for the ESW process.

ESW weld location R- face B: This QA Inspector randomly observed QC Inspector John Pagliero using the Ultrasonic Testing (UT) method from approximately Y-150 to Y-1000. QC Inspector John Pagliero informed this QA Inspector he had instructed by ABF QC Manager Jim Bowers to perform UT approximately 300 mm above and below the area where ESW had been restarted during the welding process.
